MY XXXXXXXXX

Official Number: XXXX Commerical Yacht Grt: 498 LOA: XXXX , Beam XXXX m,
Registry : XXXXXXXXXXXX .Call sign : XXXXX , BHP : 2816

WEEKLY REFIT REPORT

Period 2nd, Monday Febuary 2009 ----- 6th , Friday, February, 2009

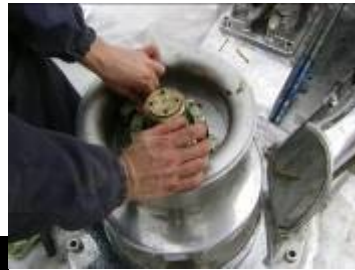
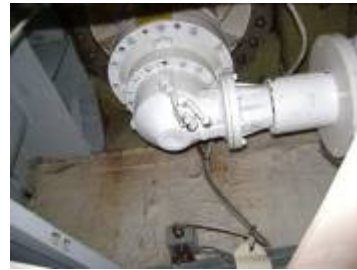
1. Rebuilding port side windlass and pipe work prep*

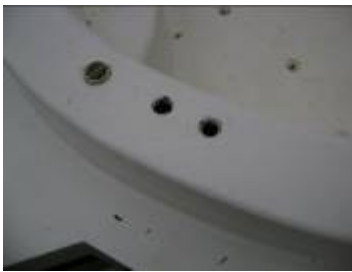
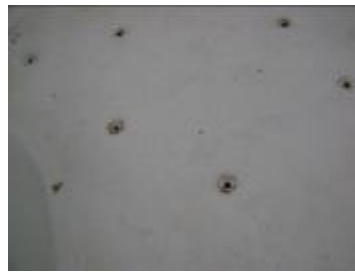
2. Stripped Jacuzzi parts*

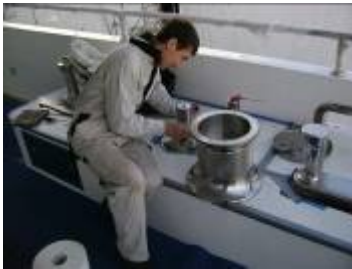
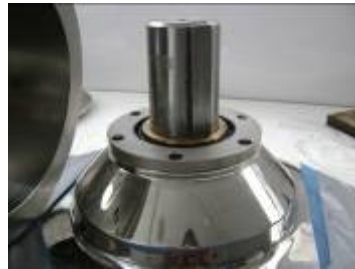
3. Stripped and cleaned aft capstans*

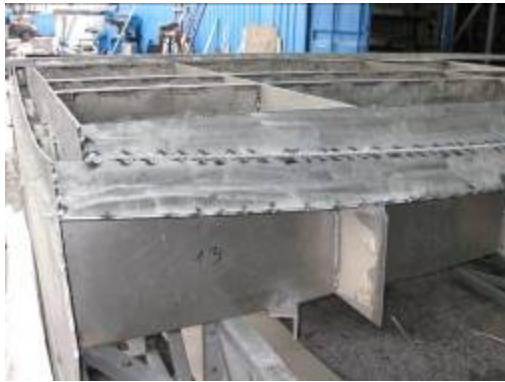
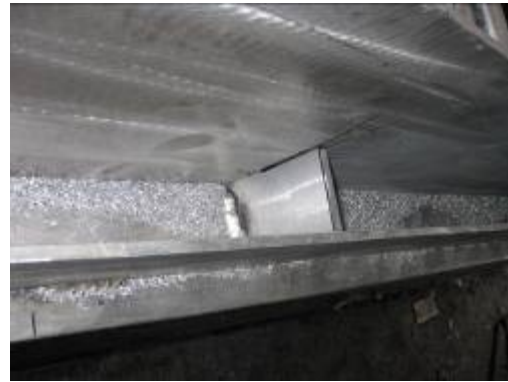
**Stern Door Construction inspection**

A site visit was arranged for inspection of the construction of the stern door. Welding and construction method of door and the manufacturing of hatch covers to be installed in the garage area where inspected. Welding was inspected for penetration depth and quality and found to be of good quality workmanship. Computer direct cutting (CDC) milling of the hatches to be installed was completed to a good standard and materials used were of good quality.
